# Correlation Between Electrical Resistivity and Microstructural Changes in SS316L Under High-Cycle Fatigue

Maryam Izadi  
Dr. Ebad Bagherpour  
Dr. Shubham Sanjay Joshi  
Prof. Zhongyun Fan

25<sup>th</sup> February 2025

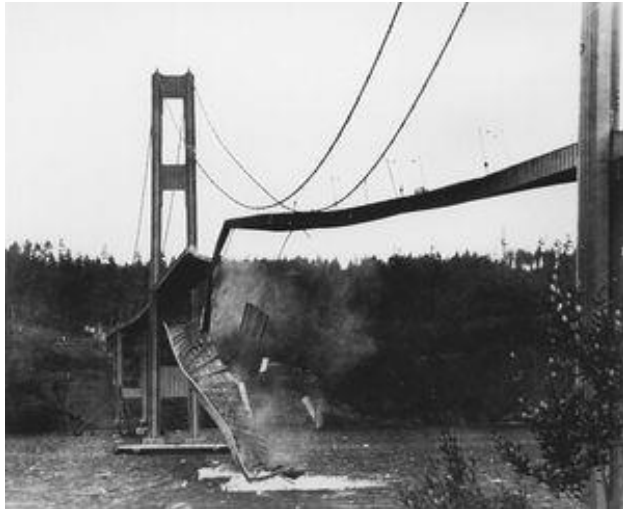
The bridge collapsed just four months after opening due to undetected vibrations and fatigue stress.

Tacoma Narrows Bridge Collapse of the Tacoma Narrows Bridge, Washington state,

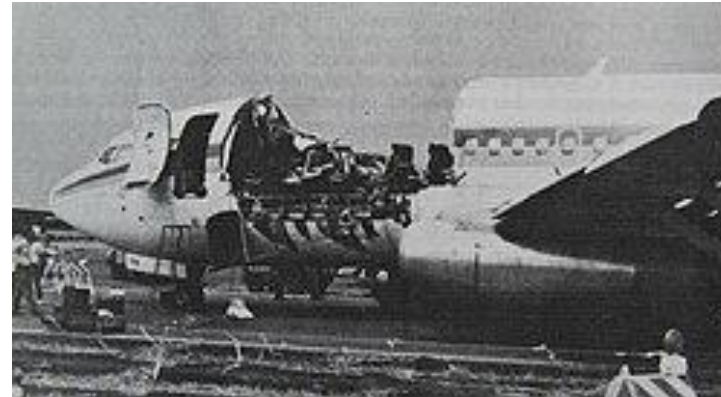
A fuselage tear caused by undetected metal fatigue. 1 death, 65 injuries

The fuselage of Aloha Airlines Flight 243 after rupturing while in flight.

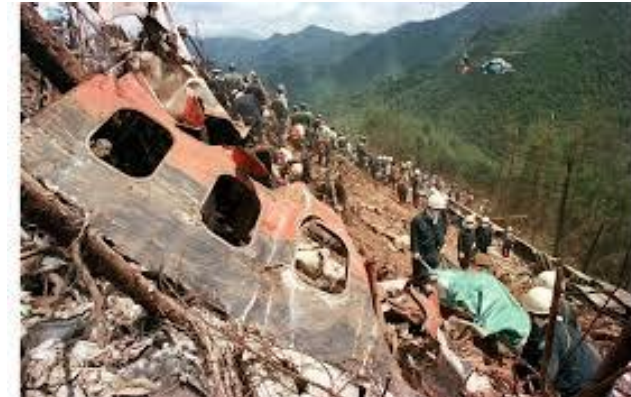
A fatigue-related bulkhead failure led to the deadliest single-aircraft accident. 520 deaths

Japan airlines flight 123 Crash.

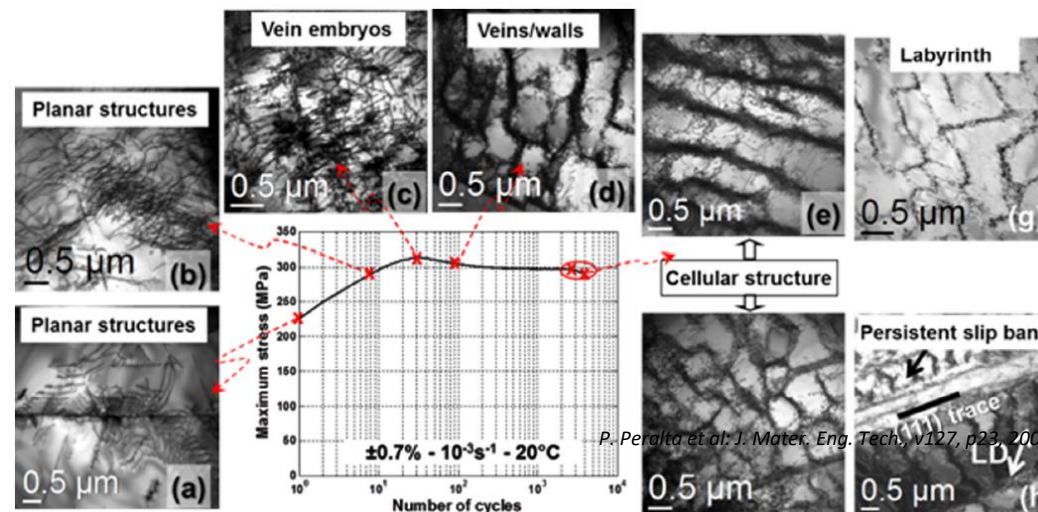
Dislocation evolution and the corresponding cyclic deformation behavior of AISI 316L steel

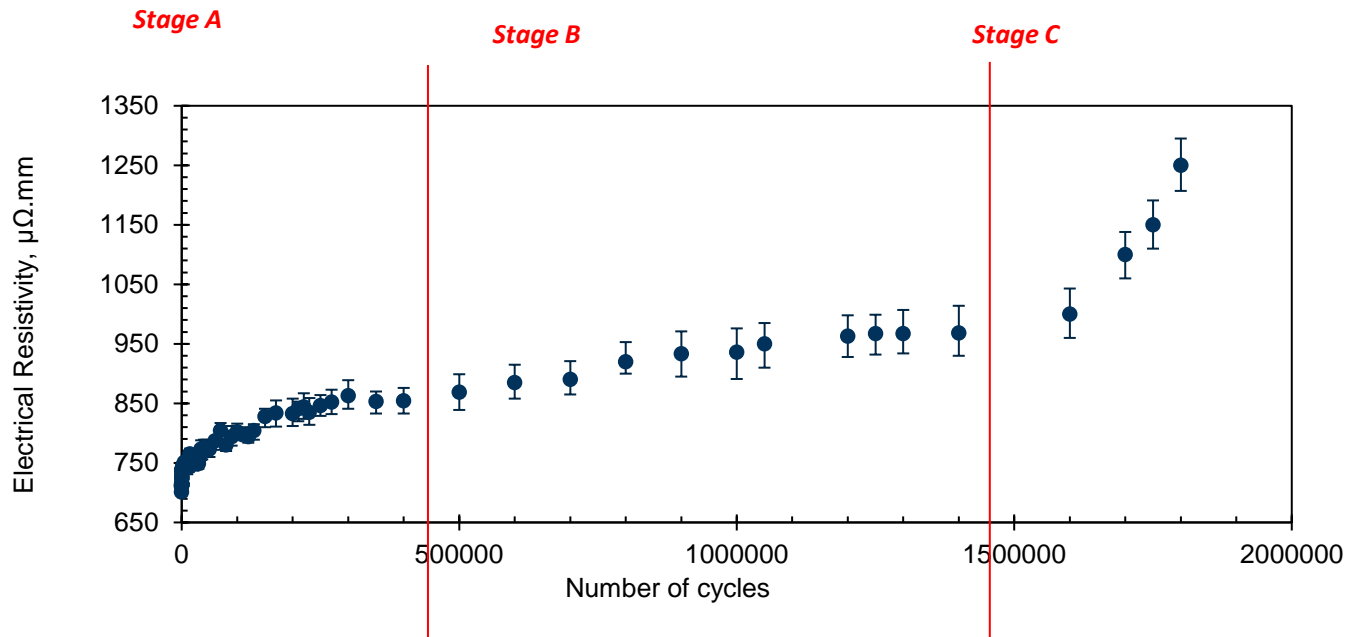
Fatigue regime :11.5 kN (400 MPa) load with an amplitude of 3.3 kN and a frequency of 10 Hz- Stainless steel 316 , Fatigue life 2,000,000 cycle

Stage A: Dislocation movement / entanglement → slight resistivity increase

Stage B: Slip line formation → gradual rise in resistivity

Stage C: Crack initiation / propagation → sharp increase in resistivity

Electrical resistivity is used as an approach to monitor fatigue damage evolution, capturing structural changes in all three fatigue stages.

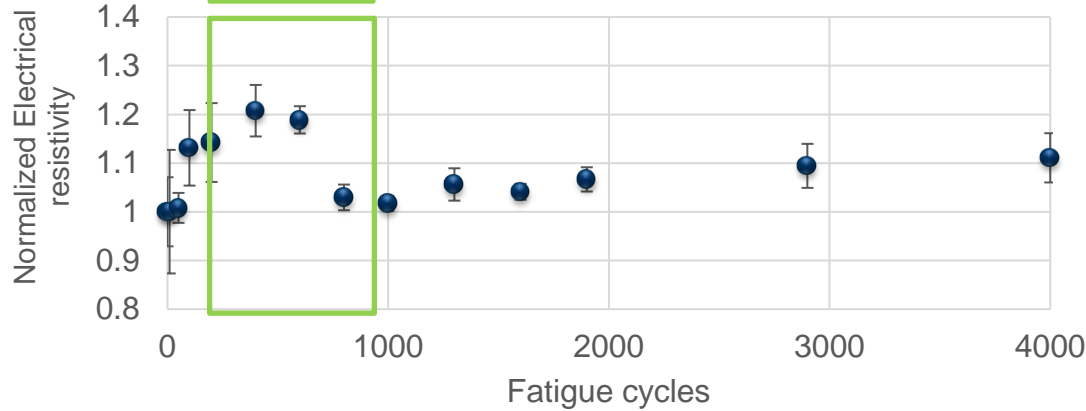
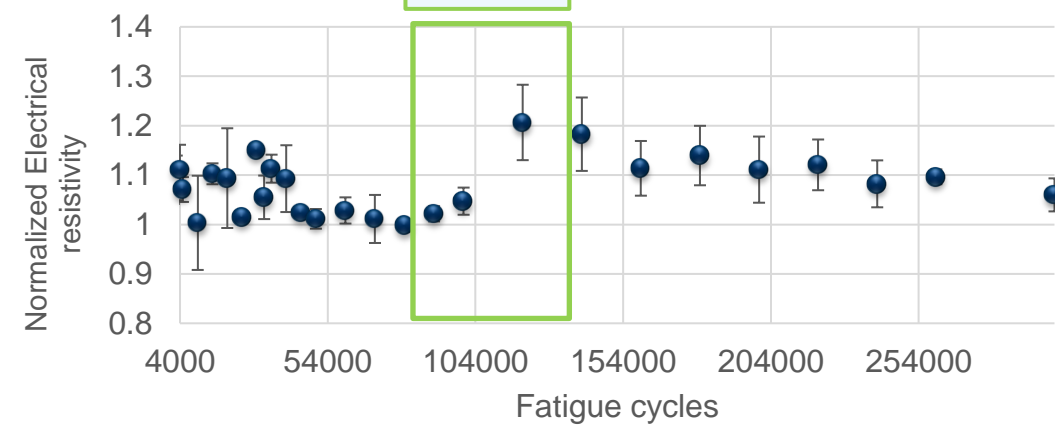
Fatigue regime : Max stress 260 MPa, R=-0.4 and a frequency of 10 Hz- Stainless steel 316 , Fatigue life 5,000,000 cycle

0.004%  
fatigue  
life

2%  
fatigue  
life

**Before reaching 20% of fatigue life, two significant fluctuations in electrical resistivity are observed, indicating key microstructural changes.**

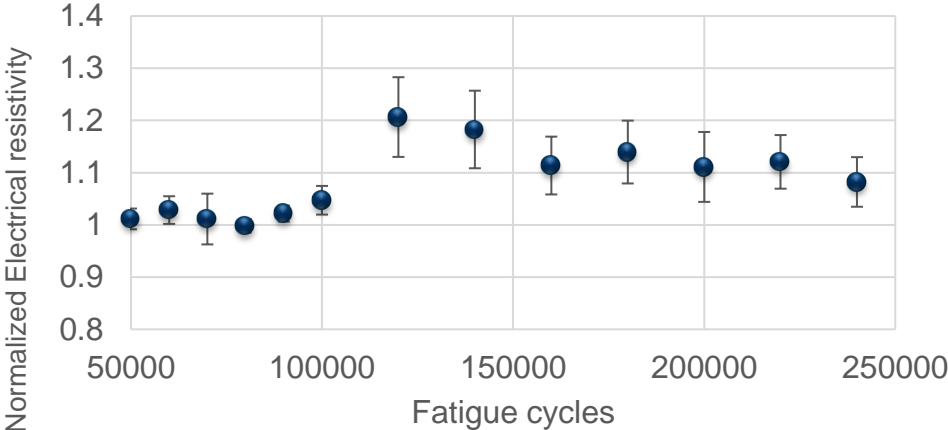
Electrical resistivity measurement by 5% fatigue life

The increasing resistivity trend correlates with the transition from ordered dislocations to dislocation cell formation, increase in dislocation density and more tangled structures of dislocations indicating.
